Need for Signs on the Segara Anakan River, Cilacap Regency

¹Febriansyah, ²Chairul Insani Ilham, ³Dion Amir Nurrokhim
^{1,2,3}Inland Water and Ferries Transport Polytechnic of Palembang

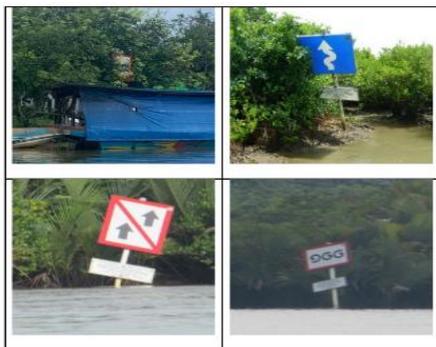
Fig 3. River signs on the Segara Anakan River

Based on observations of the Segara Anakan river channel on the Seleko - Klaces route, it was found that 5 signs were still installed out of the 9 signs that had been installed by the Cilacap Regency Transportation Service. Following are the details of the signs:

a) Prohibition Sign

There are 2 river signs with number 2 (no overtaking sign) and number 12 (no sailing to cause waves)

b) Warning sign

There is 1 river sign with the number 12 (whirlpool).

c) Guidance/instruction signs

There are 2 river signs with the number 37 (many bends)

The following is a picture of the condition of the river signs on the Segara Anakan River, Cilacap Regency.

The following is a recap of the existing condition of river signs on the Segara Anakan River, Cilacap Regency, Central Java Province.

Table 2. Segara Anakan River Sign Survey Data

No	Coordinate	Types of Signs	Sign Condition
1	07° 41' 42" S 108° 51' 31" E	Prohibition	Good
2	07° 42' 41" S 108° 55' 50" East	Instruction	Light Damage
3	07° 42' 40" S 108° 55' 43" East	Instruction	Good
4	07° 42' 43" S 108° 55' 52" E	Prohibition	Good
5	07° 42' 43" S 108° 59' 53" E	Warning	Good

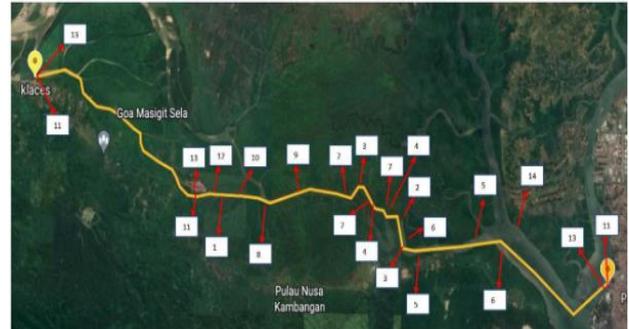
Fig 5. Sign Placement Plan

The following is a plan for placing river signs on the Segara Anakan River shipping channel

The priority for procurement and installation of signs is determined by the level of safety, order and smoothness of ship traffic in river waters. The procurement and installation priorities are related to passenger safety and security, ship safety, shipping order, and finally the smooth running of traffic.
